DEPARTMENT OF TRANSPORTATION

Quality Assurance and Source Inspection

Contract #: 04-0120F4Cty: SF/ALA Rte: 80 PM: 13.2/13.9File #: 1.28**WELDING INSPECTION REPORT****Resident Engineer:** Casey, William**Address:** 333 Burma Road**City:** Oakland, CA 94607**Report No:** WIR-028889**Date Inspected:** 14-Dec-2012**Project Name:** SAS Superstructure**OSM Arrival Time:** 700**Prime Contractor:** American Bridge/Fluor Enterprises, a JV**OSM Departure Time:** 1730**Contractor:** American Bridge/Fluor Enterprises, a JV**Location:** Job Site**CWI Name:** As noted below**CWI Present:** Yes No**Inspected CWI report:** Yes No N/A**Rod Oven in Use:** Yes No N/A**Electrode to specification:** Yes No N/A**Weld Procedures Followed:** Yes No N/A**Qualified Welders:** Yes No N/A**Verified Joint Fit-up:** Yes No N/A**Approved Drawings:** Yes No N/A**Approved WPS:** Yes No N/A**Delayed / Cancelled:** Yes No N/A**Bridge No:** 34-0006**Component:** SAS OBG**Summary of Items Observed:**

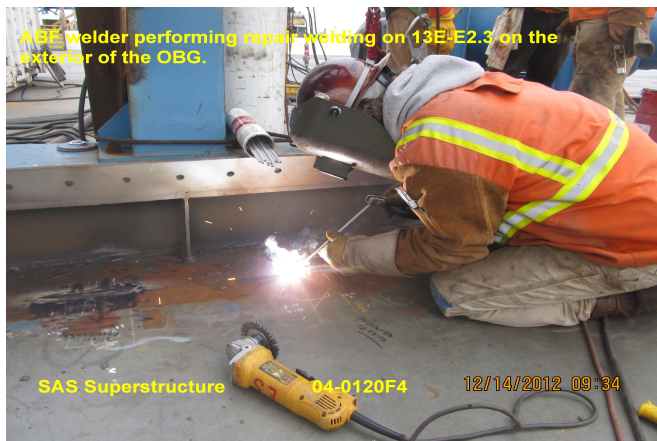
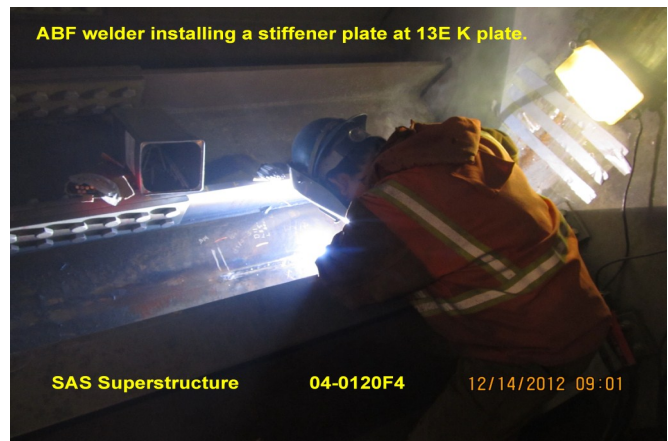
ABF welder Rick Clayborn #2773 was observed performing weld repairs on 13E-E2.3 at y=3810mm. The dimensions of the excavation was recorded as; 30L/20W/7D. The welder was observed utilizing WPS ABF-WPS-D15-1004-Repair-Revision 0 for SMAW. The welder was observed preheating the welds prior to Carbon Arc Gouging and welding. Other welding parameters as inspected by the QC Inspector appeared to be in compliance with the WPS noted above. RWR-201212-020 was referenced during the repair.

ABF welder Eric Sparks #3040 was observed performing ongoing weld repairs on 13E-E2.3 at y=850mm and y=1500mm. The welder was observed utilizing WPS ABF-WPS-D15-1004-Repair-Revision 0 for SMAW. The welder was observed preheating the welds prior to Carbon Arc Gouging and welding. Other welding parameters as inspected by the QC Inspector appeared to be in compliance with the WPS noted above.

ABF welder Wai Kit Lai #6965 was observed performing ongoing weld repairs on 12W-W2.1-C1.1 at y=770mm. The welder was observed utilizing WPS ABF-WPS-D15-1004-Repair-Revision 0 for SMAW. The welder was observed preheating the welds prior to Carbon Arc Gouging and welding. Other welding parameters as inspected by the QC Inspector appeared to be in compliance with the WPS noted above. RWR – 201211-005 was referenced

ABF welder Richard Chounard #8959 was observed performing SMAW the X297-02 retrofit stiffener at the E line K plate. The welder was observed utilizing WPS ABF-WPS-D15-F1200A-Revision 0 for SMAW. The welder was observed preheating the welds prior to welding. Other welding parameters as inspected by the QC Inspector appeared to be in compliance with the WPS noted above.

ABF welder Richard Chounard #8959 was observed performing SMAW the X2007-01 retrofit stiffener at 13E PP121.5-E2.0. The welder was observed utilizing WPS ABF-WPS-D15-F1200A-Revision 0 for SMAW. The welder was observed preheating the welds prior to welding. Other welding parameters as inspected by the QC Inspector appeared to be in compliance with the WPS noted above. This work was observed to be in progress.
